ADVANCED V/STOL PROPELLER CRITICAL COMPONENTS INVESTIGATION

Hamilton Standard Division
United Technologies Corporation
Windsor Locks, Conn. 06096

April 1976

Final Report for Period February 1973 - June 1975

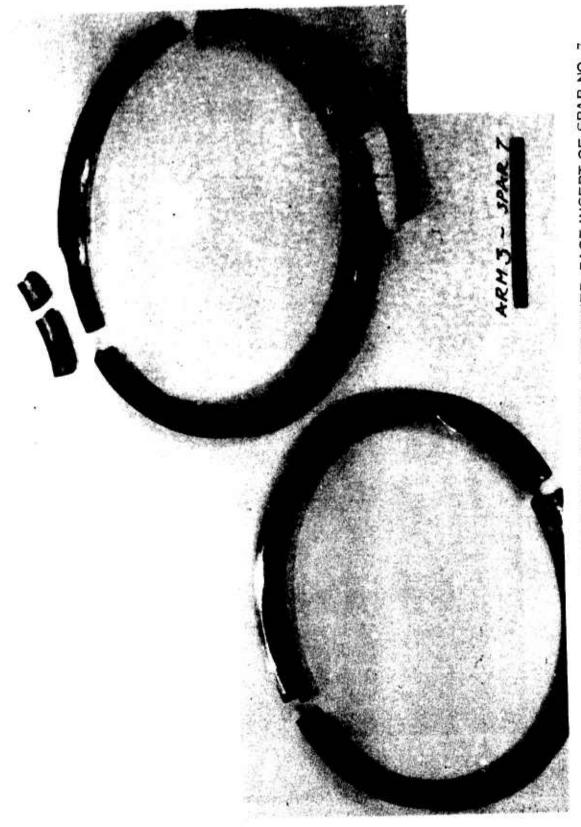
FIGURE 68, OUTER-RACE INSERT OF BARREL ARM NO. 3 AND INNER-RACE INSERT OF SPAR NO. 7

The race inserts from the number three barrel arm and the number seven spar are illustrated in Figure 68. The inner race segments were not fractured, as shown in Figures 69a through 69d. One section had a circumferential crack extending from a split end for approximately 90 degrees. This is shown in Figure 69c. The outer race insert had two radial fractures and circumferential fractures which permitted the separation of three small segments from the ring. The cracks and ball contact pattern for this element are shown in Figure 70a through 70d. Figure 70a shows the split and light ball impressions. Figure 70b is a view 90 degrees from Figure 70a and shows the circumferential crack looping between ball impressions. Figure 70c is a view 180 degrees from Figure 70a. Finally, 70d is a view 270 degrees from Figure 70a.

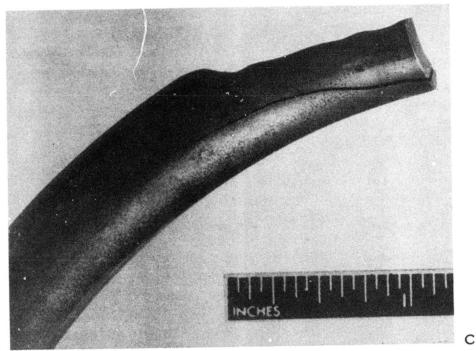
FIGURE 79.

The top row of Figure 79a illustrates the outer-race inserts, while the bottom row illustrates the inner-race inserts from barrel arm two. From the number two barrel arm position, one of the outer-race inserts had two radial fractures, and a small section was broken away from one of the inner-race inserts. This is shown in Figure 79b and 79c, where a second crack, parallel to the fracture on the inner race insert, can be seen. Again, the fracture surfaces revealed that the origins were located at ball impressions.

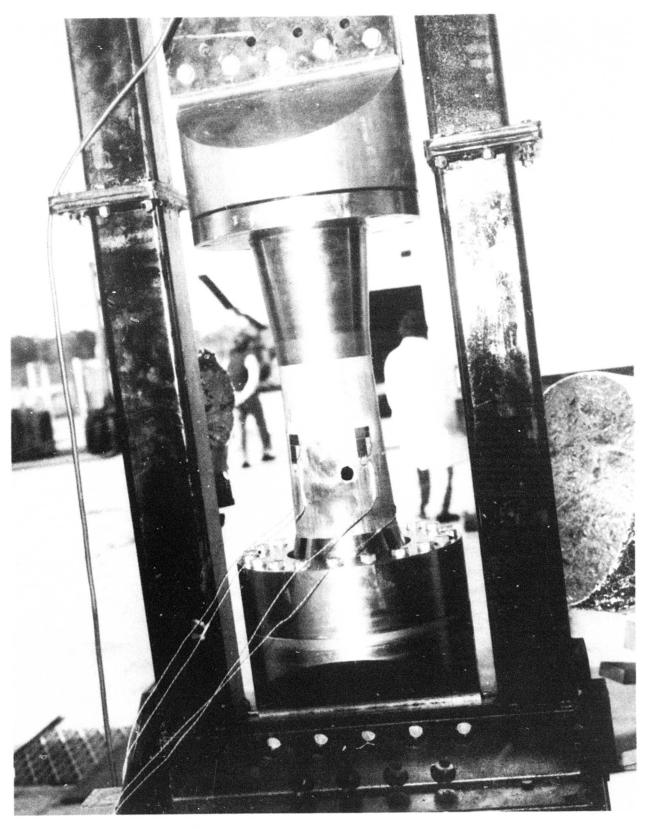
Figure 105 shows the tensile loading machine and specimen number one following impact by the 14.5 mm projectile.

FIGURE 105. TENSILE LOADING MACHINE WITH SPECIMEN NUMBER 1
FCLLOWING IMPACT BY 14.5 MM PROJECTILE

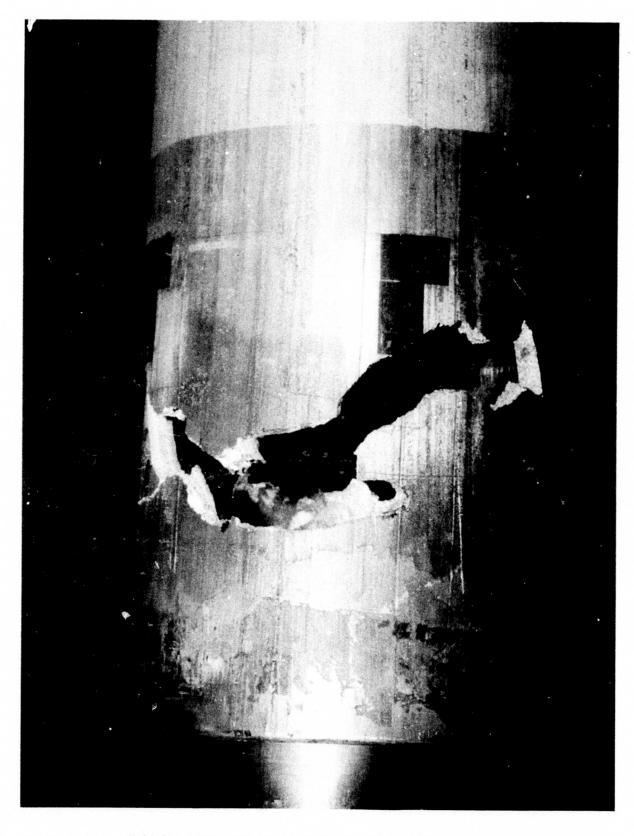
Figures 106 through 111 show the circumferential path of the fracture experienced by specimen serial number two after sustaining three tumbled 0.30-06 caliber strikes and undergoing tension-tension fatigue tests.

FIGURE 110. BALLISTIC SPECIMEN NUMBER 2 FATIGUE TEST FRACTURE, 180° TO 300° OF REVOLUTION
